# QUALITY ASSURANCE AUDIT OF APIOS DEPOSITION MONITORING NETWORKS

Ontario Ministry of the Environment  
Air Resources Branch

The Environmental Applications Group Ltd.

March 1988

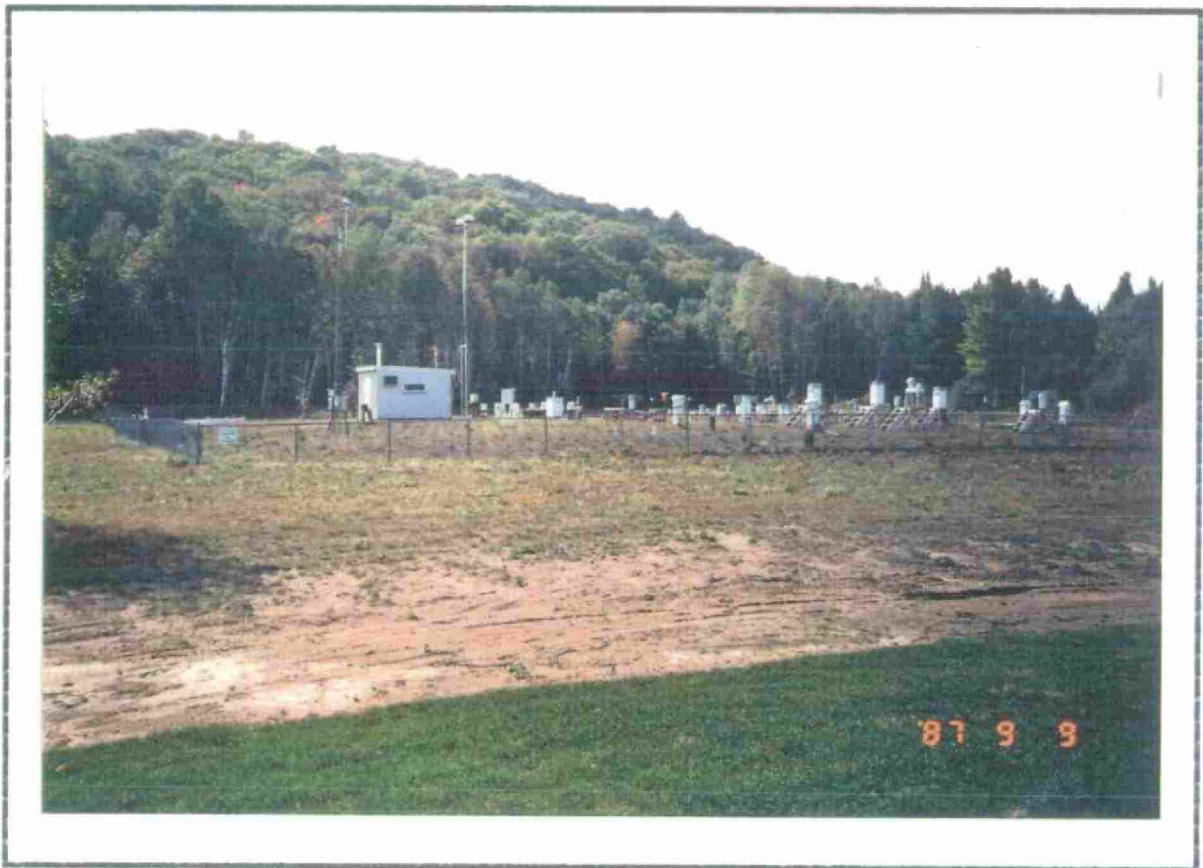
Plate 3  
**DORSET**

Dorset monitors are potentially exposed to wind blown dust from sources in the immediate vicinity. There is an open sandy area approximately 50 to 100 m to the northeast of the site, due to recent construction activities, and access roads are either gravel or dirt. During a dry summer such as this one there is thin ground cover in the instrument enclosure itself (see photographs in Appendix 2). During the audit, sodding was being carried out over the ground exposed by the construction activity (see Plate 3).

The sequential sampler boom has a double head which is very heavy. When released, the boom swings down with a torque which can exceed that applied by the operator. This poses a safety hazard (for example the end of the boom could strike the operator).

#### **Recommendations**

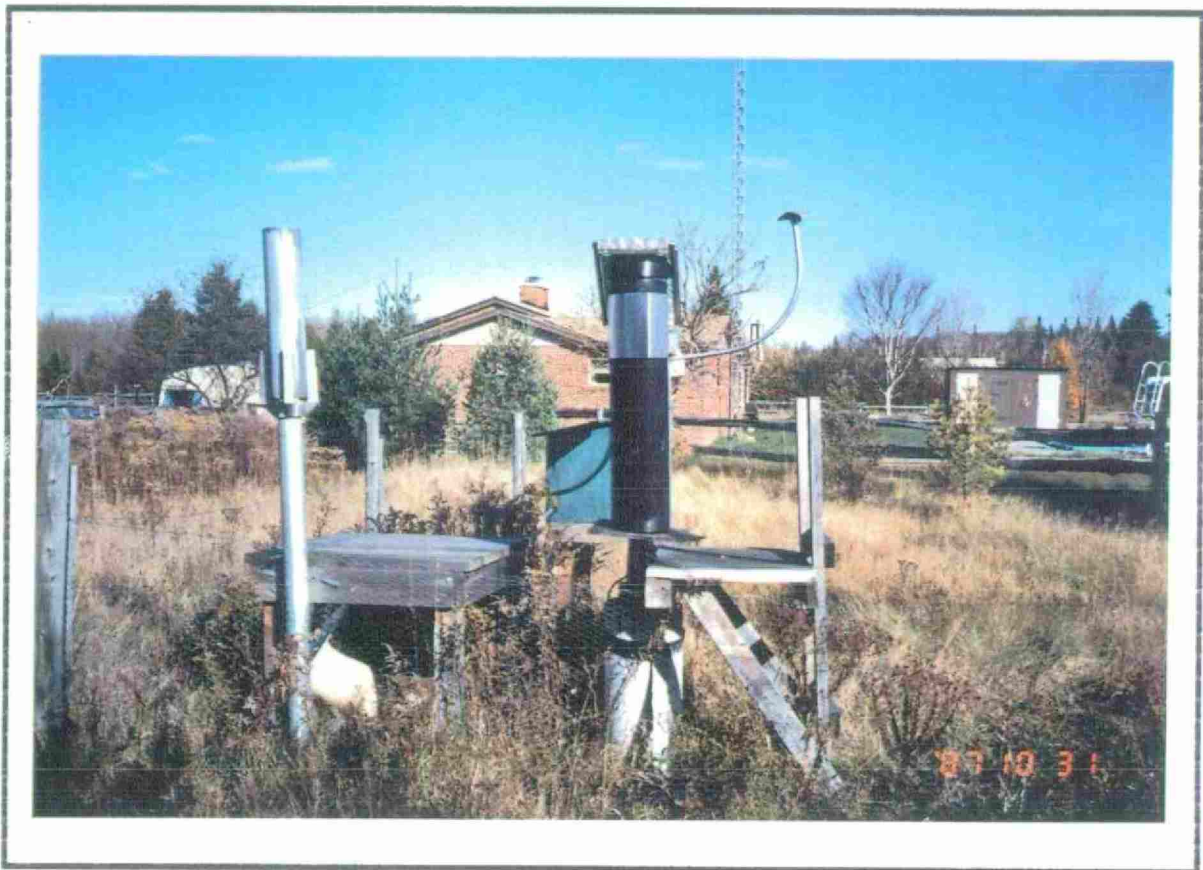
Plate 4  
**UXBRIDGE**

The possibility of sample contamination due to the close proximity to the house and pool should be documented at the data assessment office. The operator should keep a record of activities which can affect the sample quality. This record should take the form of :date, activity type (eg. barbeque), time, duration, estimated observed wind speed and direction. The operator should be advised as to which activities can affect sample quality.

If the above recommendations are carried out the site rating can be changed to marginal. If, in addition, the road can be fully screened from the site and the operator can minimize activities which affect sample quality then a rating of adequate could be considered.

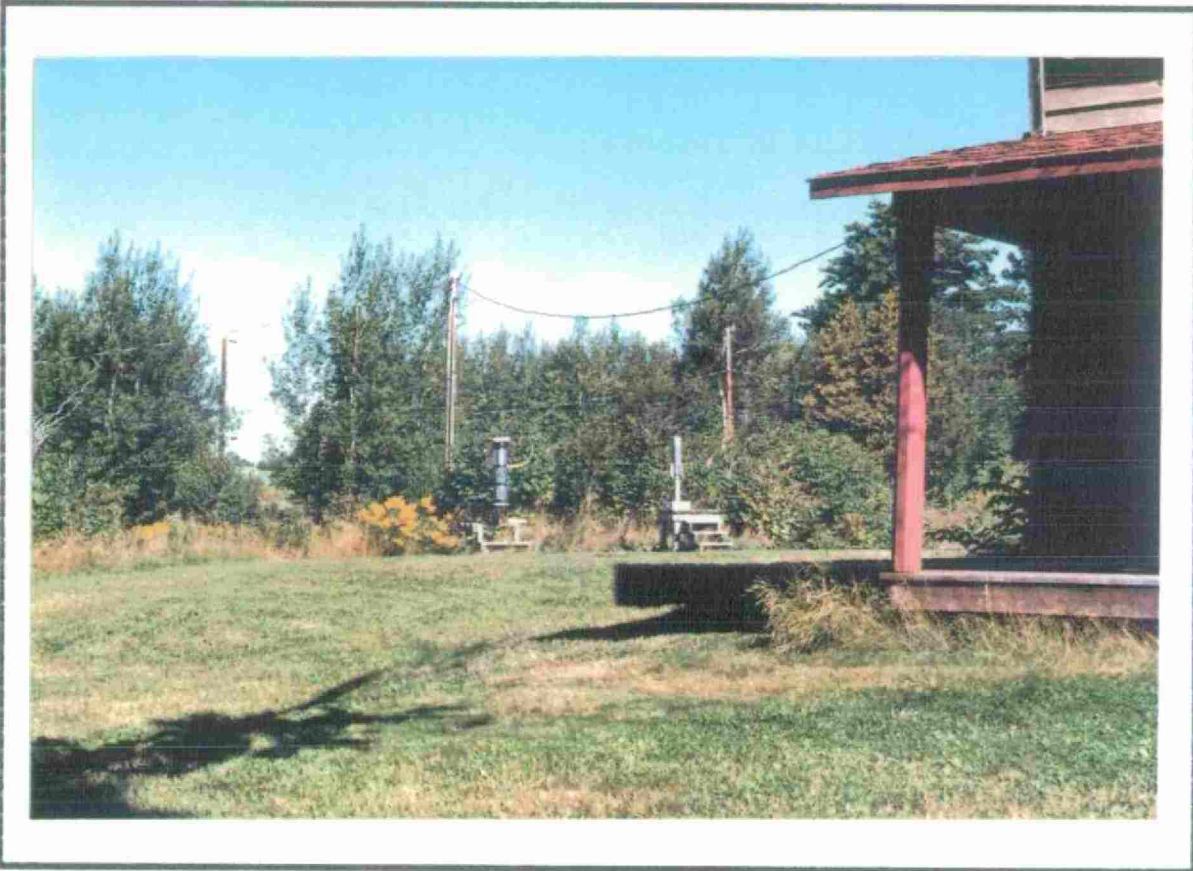
Plate 8

Over 40 pounds of pull was required to activate the hood clutch. All other aspects of the operation appeared well maintained (i.e. level monitors, smooth hood operation on Sangamo, etc.). The operator was audited regarding operation of the sampler. He was not sufficiently aware of the potential for sample contamination and appeared to be doing the sampling solely because he was assigned by the band. Although the sampler is next to the office, where the operator works, the sensor grids or hood gasket are never cleaned by the operator. Normally the Sudbury technician undertakes these duties but this means routine maintenance can be interrupted for 2 to 3 months per year because access is limited at freeze-up and break-up.

The operator should be instructed to turn off the Sangamo when grass is cut and refuse is burned in the barrel to minimize sample contamination.

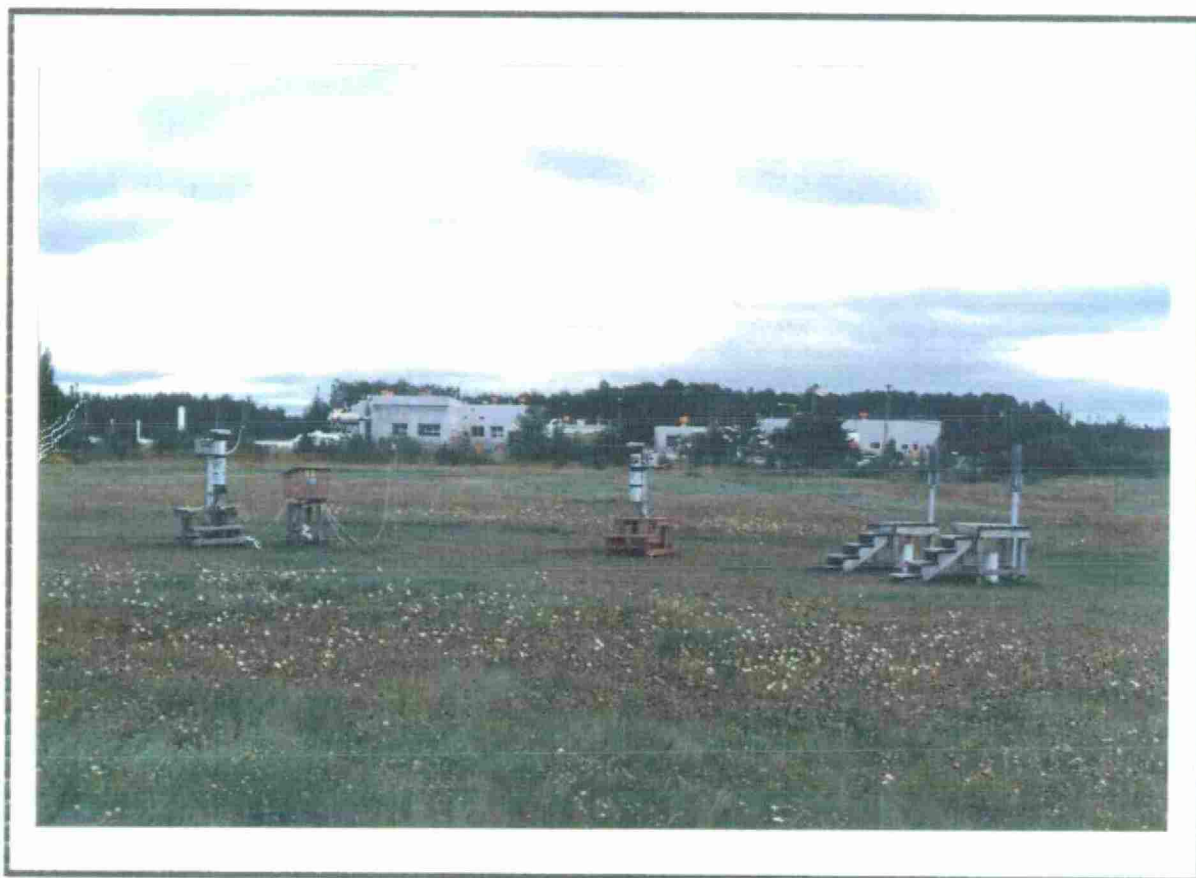
Plate 10  
**GERALDTON**

natural gas. The use of calcium chloride on the gravel access road should keep dust generation to a minimum during dry summer periods.

Maintenance of the instruments on the site is adequate with some minor items needing attention such as out of level storage gauges and a missing guy wire on the lo-volume sampling head support. A dead bird was found in one of the storage gauges. This would affect the measurement of gauge depth.

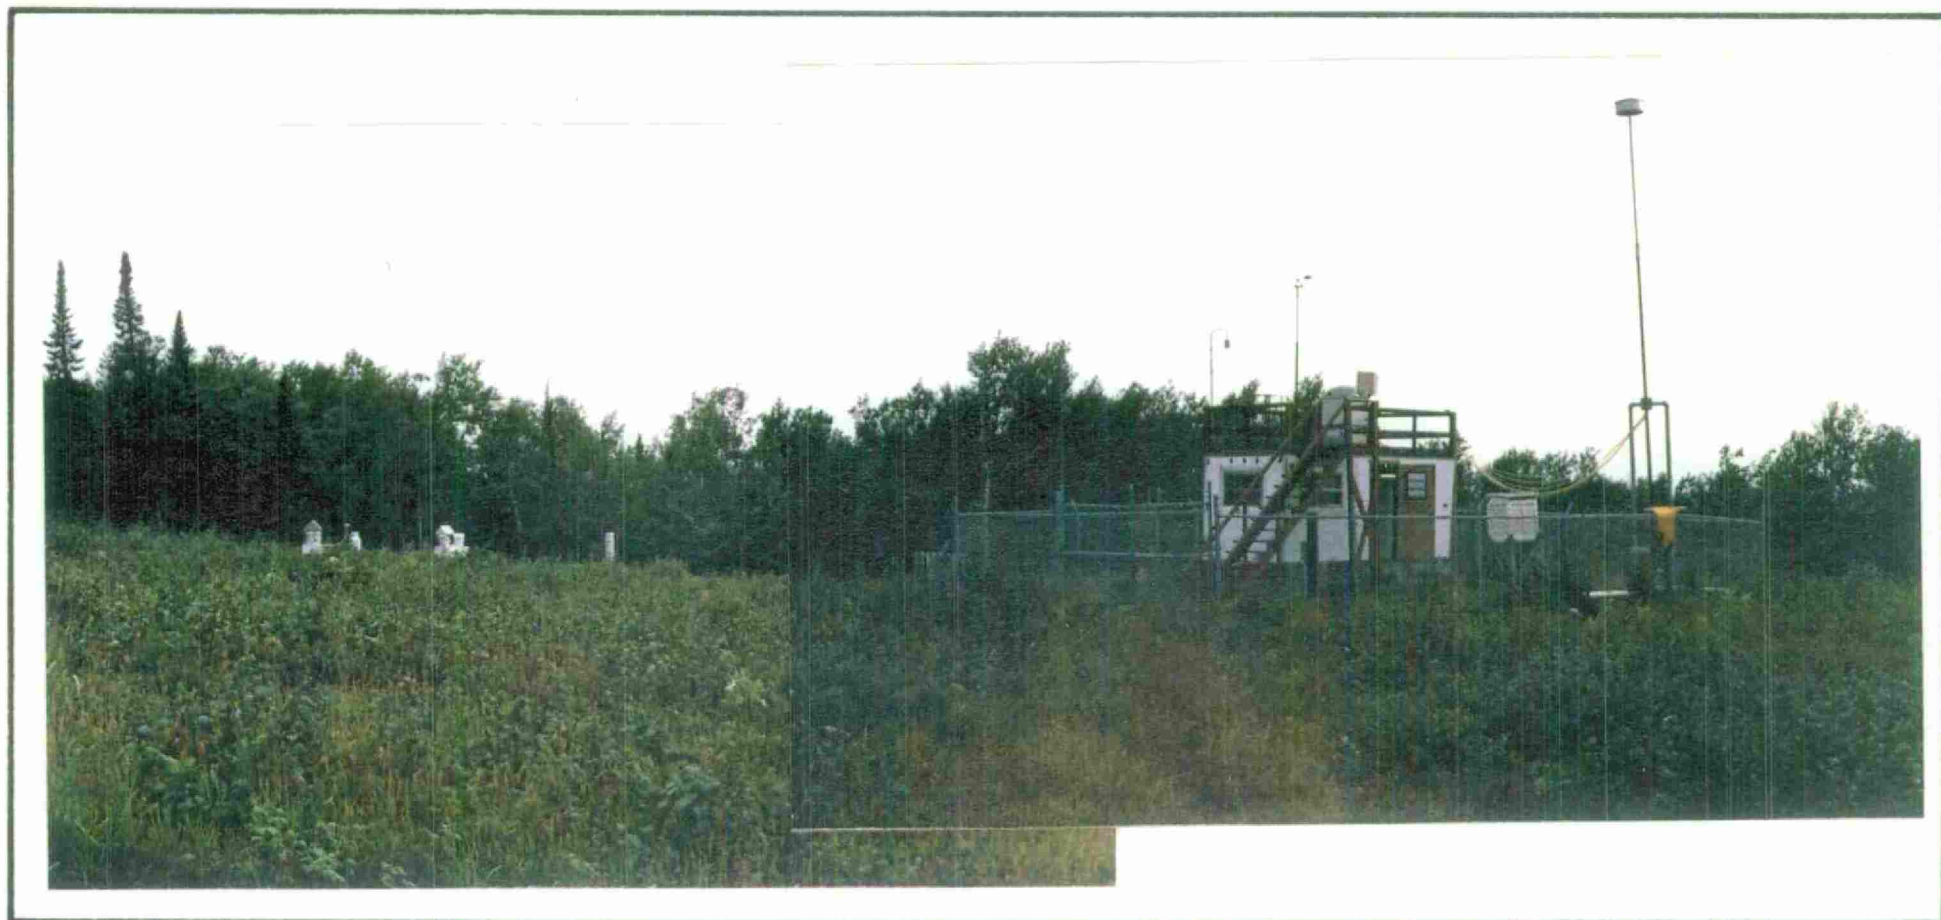
Plate 12  
FERNBERG

a problem during the audit in August). During this season, the actual siting might be considered to be only good to marginal due to entrainment of biological material by samplers.

The Aerochem was not closing properly during light rain at the site; the hood was oscillating between dry and wet. The technician repaired the unit during the audit. There was a 1/2 cm gap between the top of the bucket and the hood. It had been previously adjusted with pieces of wood underneath the collector bucket.
